Our ref: EJM/CE/17016-02

RE: THE FUTURIST, LIME STREET, LIVERPOOL

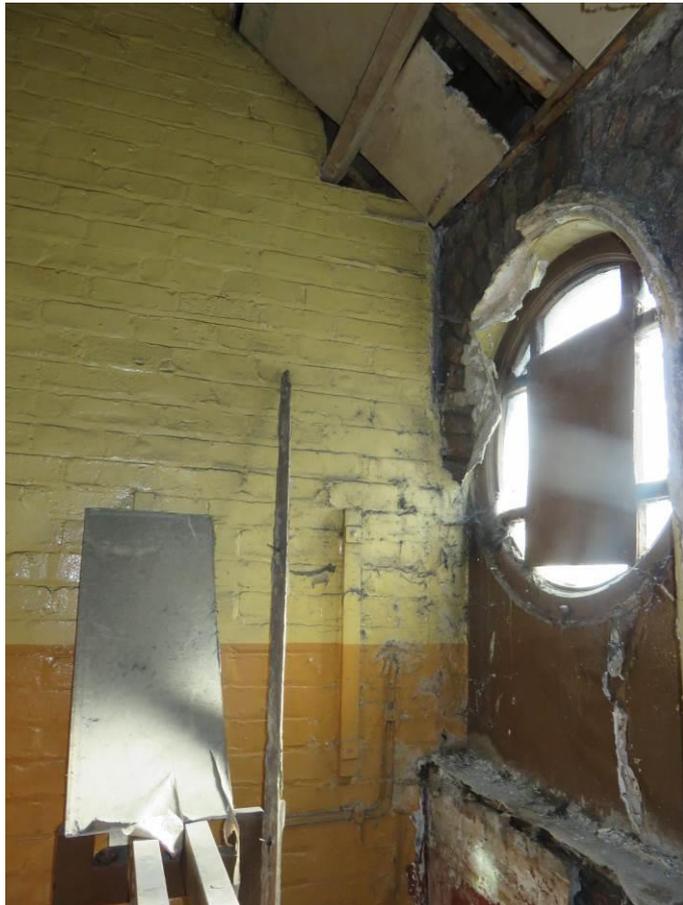
At second floor level there are quite a number of cross walls which appear to be bonded into the front wall. This is positive as they will provide lateral stability to this element. More particularly there are no signs of cracks to these, near the front wall, which one would expect if there was progressive outwards movement of this wall. Only one cross wall had a crack but this had been strapped some while ago as a temporary measure and not opened further. See photographs 1 and 2.

Photograph 1: Cross wall to front elevation providing lateral restraint and with no evidence of cracking

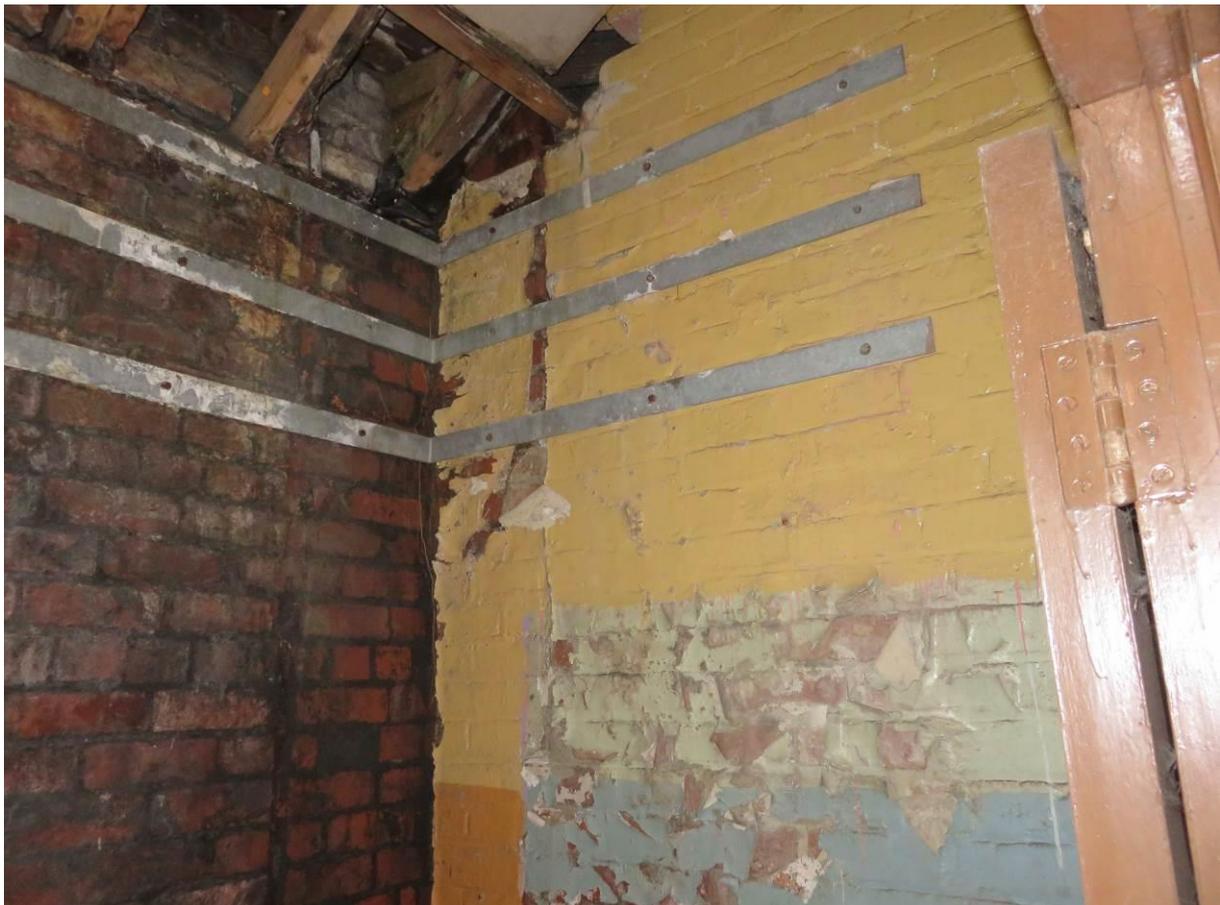
Photograph 2: Cross wall with temporary restraint straps

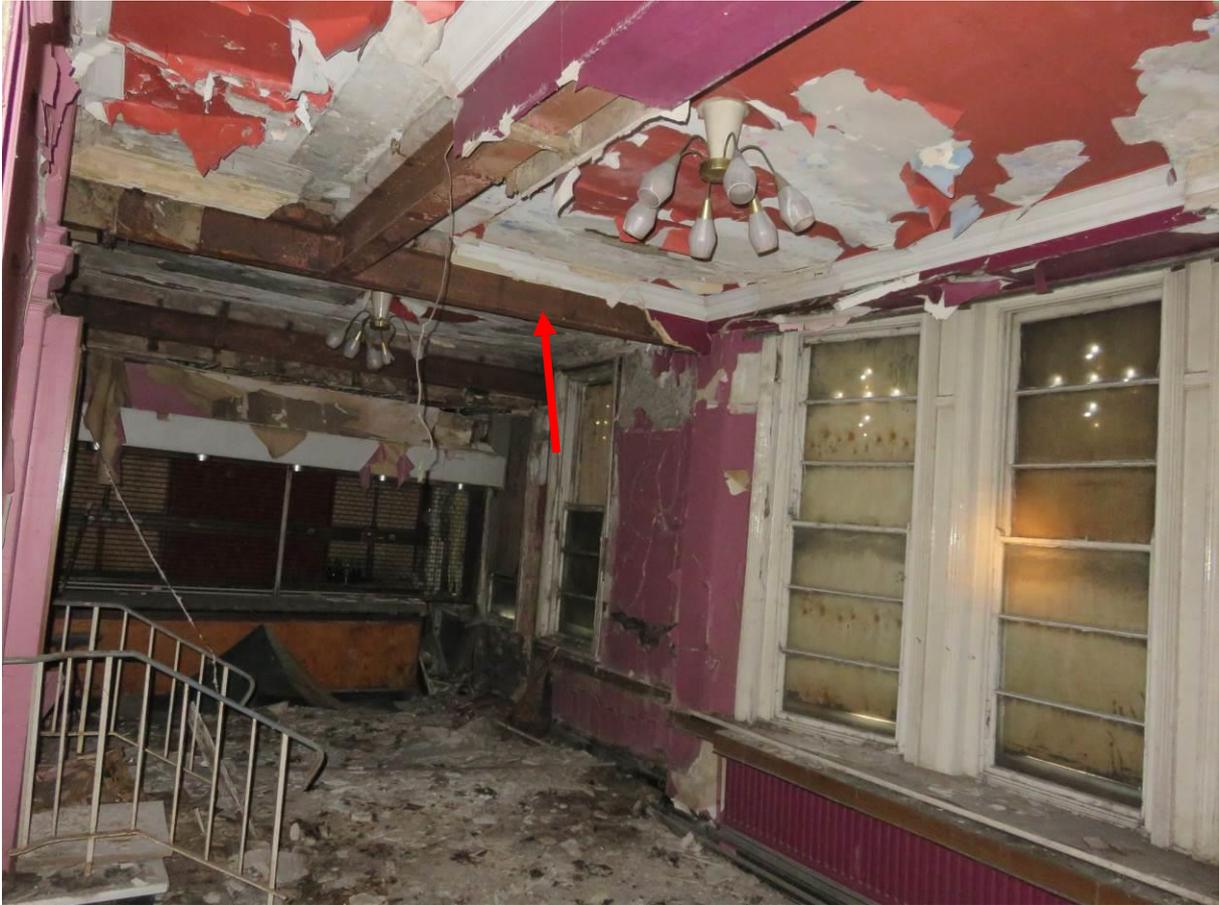
These second floor cross walls are mainly supported on steel beams below spanning across the first floor room (the bar I assume) and which is open for the width of much of the front elevation. These were not as badly corroded as reported where these enter the front wall, and I didn't see evidence of any significant corrosion jacking affecting the wall. See photographs 3 and 4. However I did that some of these extend back and bear on further steel lintels over doorways which are in poor condition. So some temporary propping of these beams and/or the affected lintels would be appropriate. The first floor here is largely timber with a significant void below to the 'filler joist' structure of the ceiling to the ground floor lobby.

Photograph 3: First floor room with steel beams spanning front elevation back to the cross wall behind

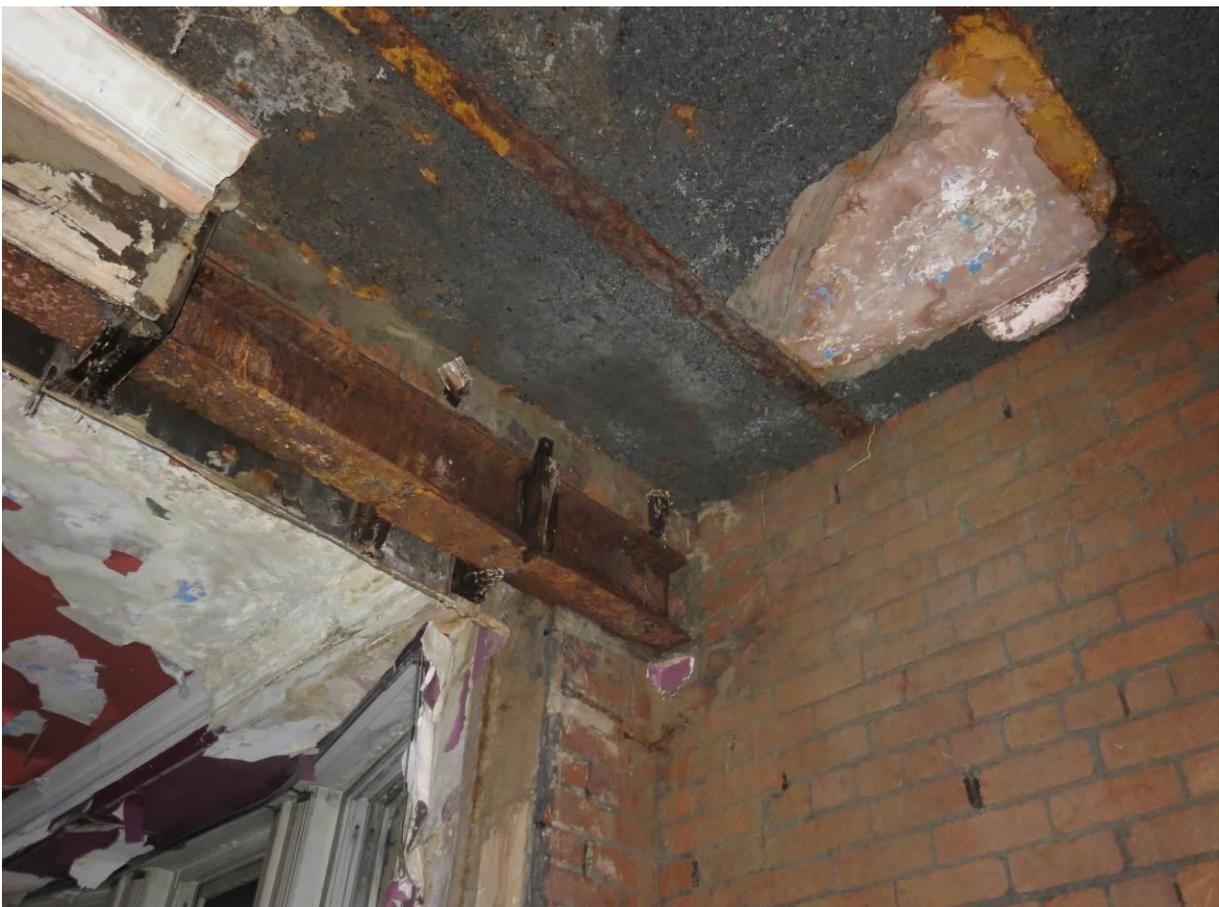
Photograph 4: Steel beam to front elevation with no evidence of corrosion jacking to built-in end

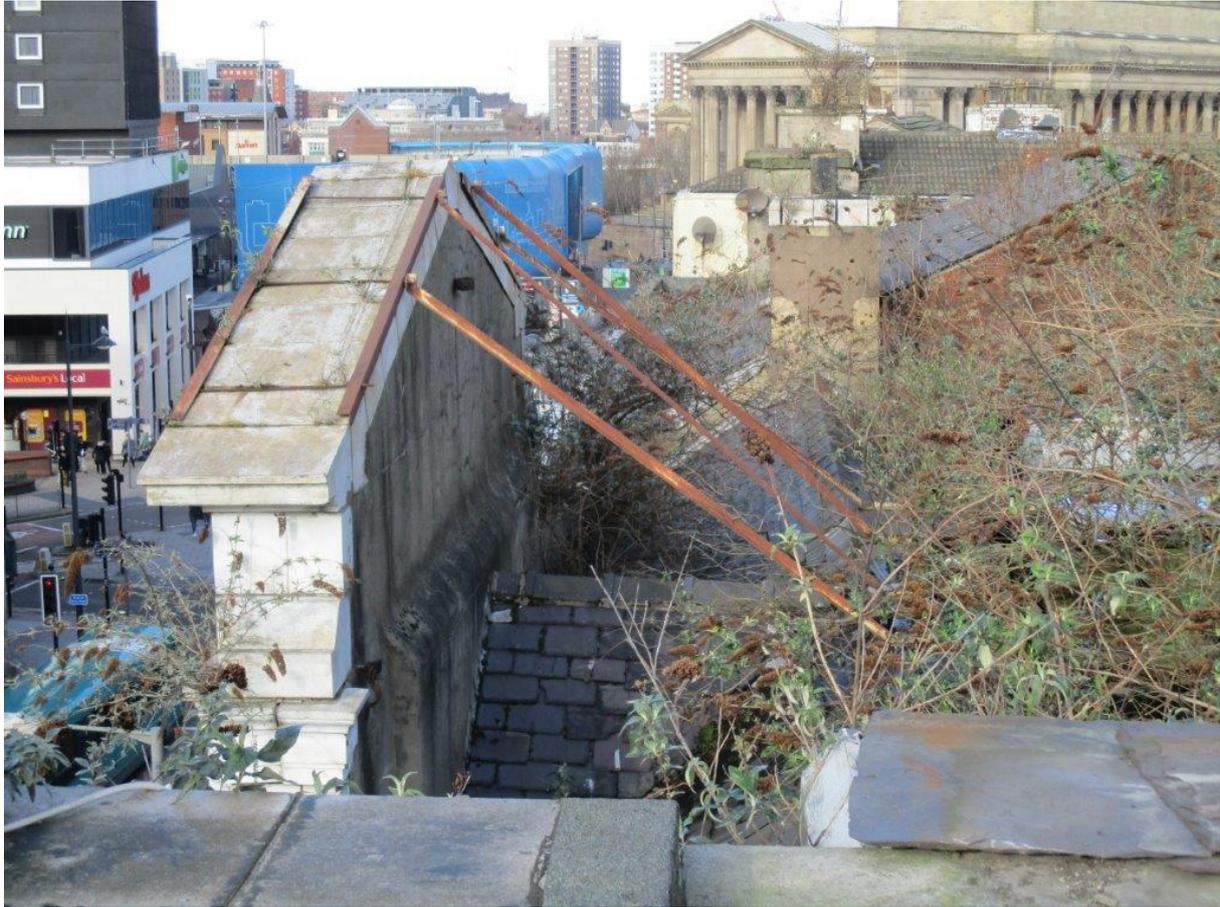
With regard to the pediment, I have been provided with the high level images including the steel restraint angles back to the timber roof structure behind. It seems likely that the ends of these are residing on decayed timber structure and thus in reality I suspect are offering only nominal restraint, if any. Thus I do consider that the pediment section is vulnerable, particularly in strong wind conditions.

Photograph 5: Restraint straps to pediment

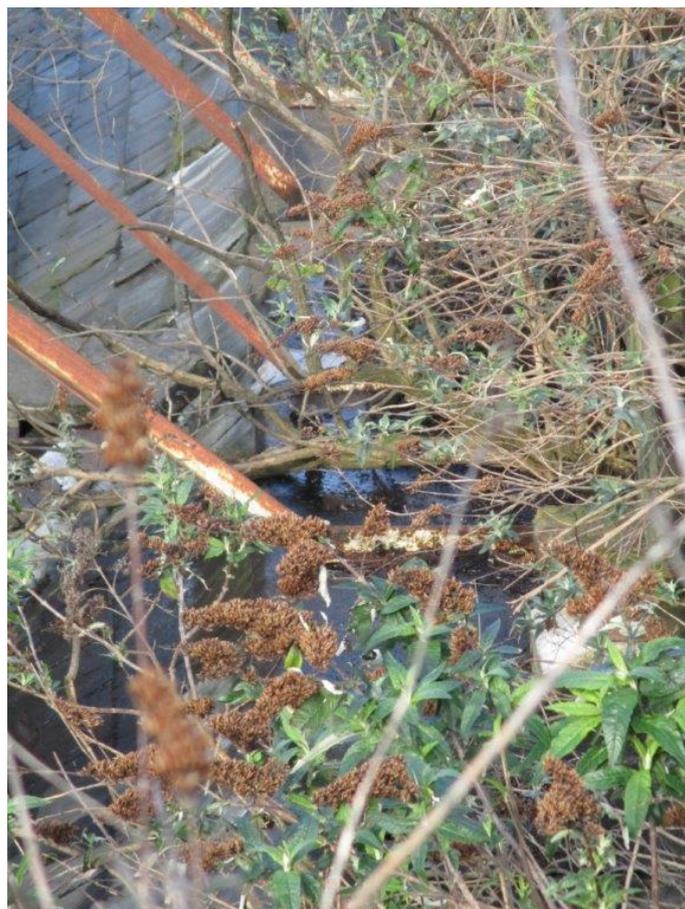
Photograph 6: Base of restraint straps

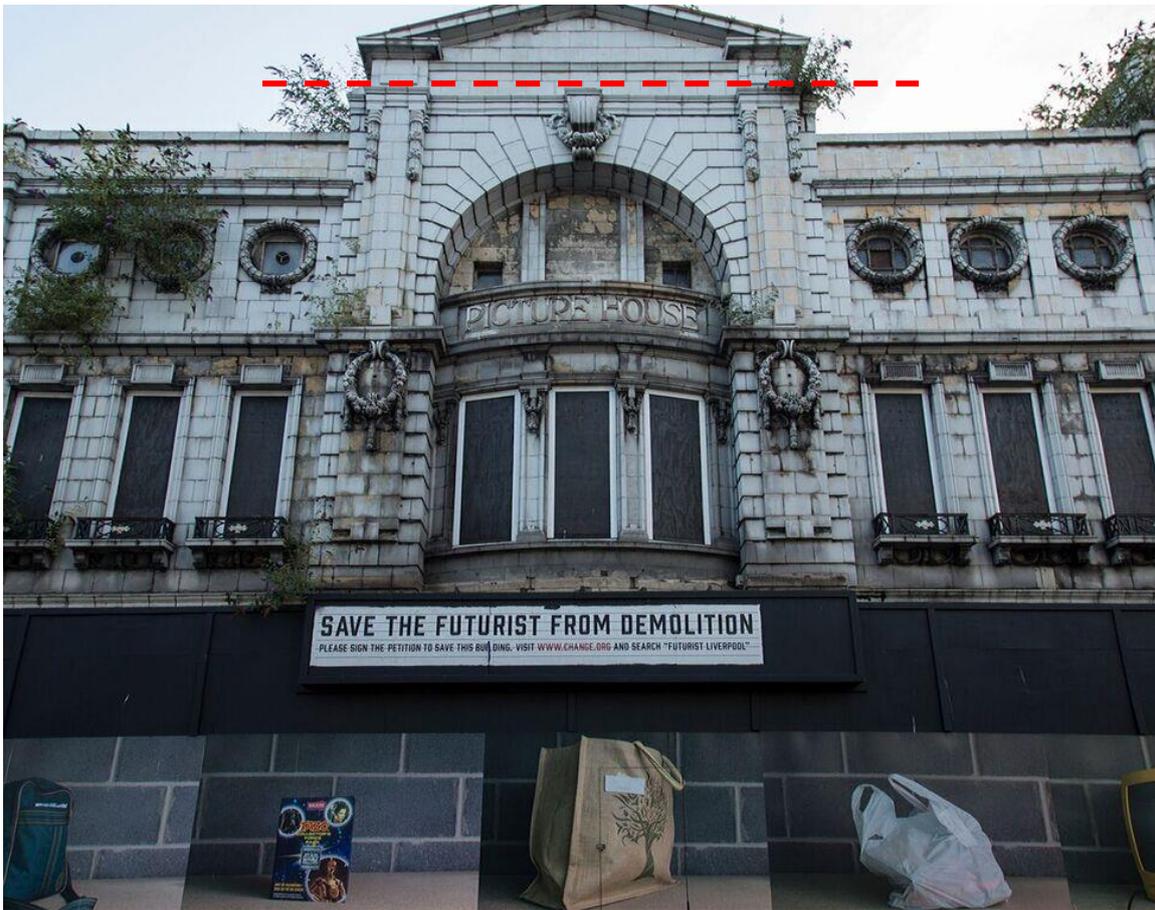
Photograph 7: Suggested position of dismantling

I note that they intend to only take the minimum amount of structure down at present but suggest that this will need to include the central arch at second floor level. Firstly I suggest that the extent of dismantling should be limited down to just above the string course to the pediment as shown on the marked-up photographs appended as photographs 7 and 8. This is the position where the wall steps out in thickness at the rear, as well as where the engaged piers or pilasters exist to the front elevation, which should offer greater stiffness to the elevation. If necessary it should be possible to provide some additional lateral restraint from the rear in the form of scaffold raking buttresses – I note that Greg Allen in the sixth paragraph of his email dated 26th April is suggesting the scaffolding contractor will return to assess some internal works so it could be part of these, but of course will need to be assessed once the roof structure behind is removed as indicated.

This will leave sufficient masonry over the central arch for this to be self-stable. However it should also be possible to insert temporary centering below the arch if necessary, and back propping below in the foyer, although I suspect this is unlikely. It will be important to cap over the head of the wall to protect this and ensure water ingress into the wall core is minimised.

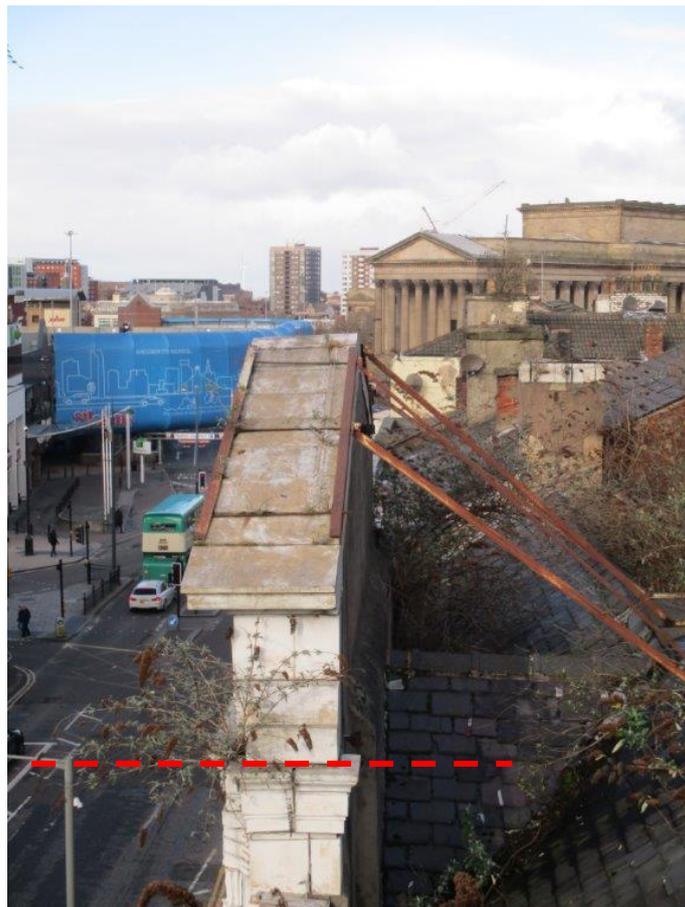
Photograph 8: Suggested position of dismantling
